THE DOME OF THE ROCK IN JERUSALEM

A Description of its Structure & Decoration

ERNEST TATHAM RICHMOND

FELLOW OF THE ROYAL INSTITUTE OF BRITISH ARCHITECTS
CONSULTING ARCHITECT TO THE NOBLE SANCTUARY IN JERUSALEM

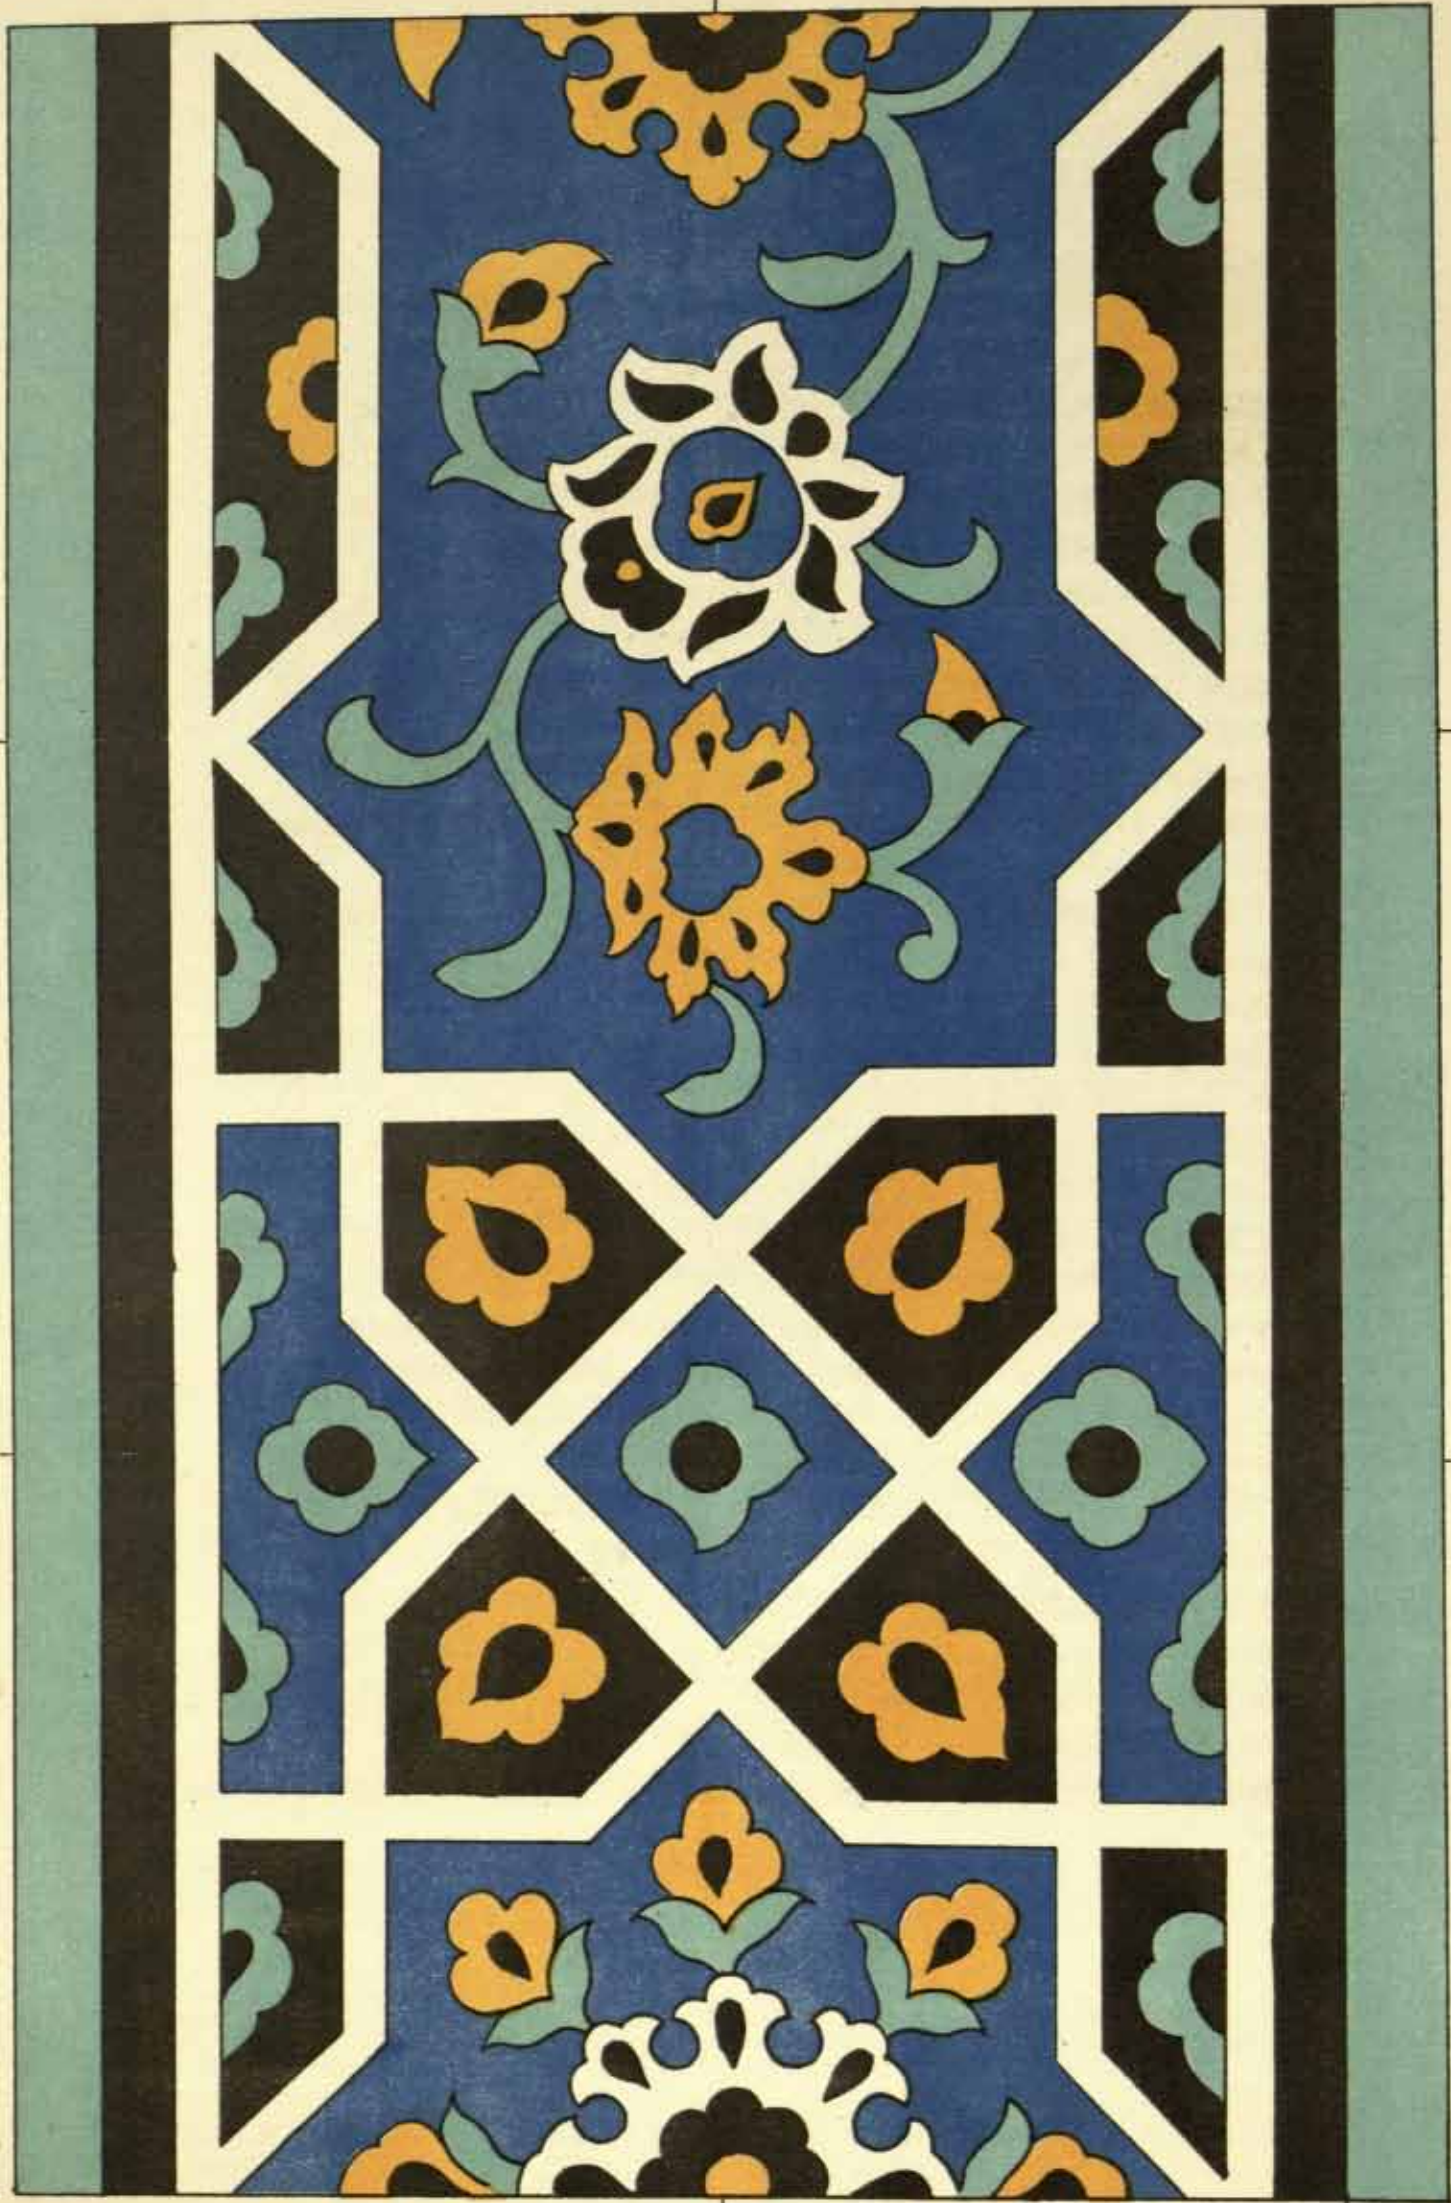
Fig. 16. Tiles of the First Period, showing a strong colour effect

Scale 1 : 2

design shown in Fig. 16. The design is on a dark blue ground, while the ground of the adjacent spandrels formed by the quatrefoils is black. The other colours used are white, green, yellow, and turquoise, the same colours as are used in the enamelled type. In the glazed type they are not so brilliant, nor is the turquoise of the same clear blue, but tends more towards green. The lines enclosing the panels are white, and outside the white line there is a black and then a green line. The flowers are white and their stems turquoise. Other examples of these tiles are found scattered on the different façades, chiefly on the parapet wall, where they have been used, among others of similar pattern (but belonging to different dates), to enclose the panels that now form the decoration between the cornice and the great inscription of the octagon.

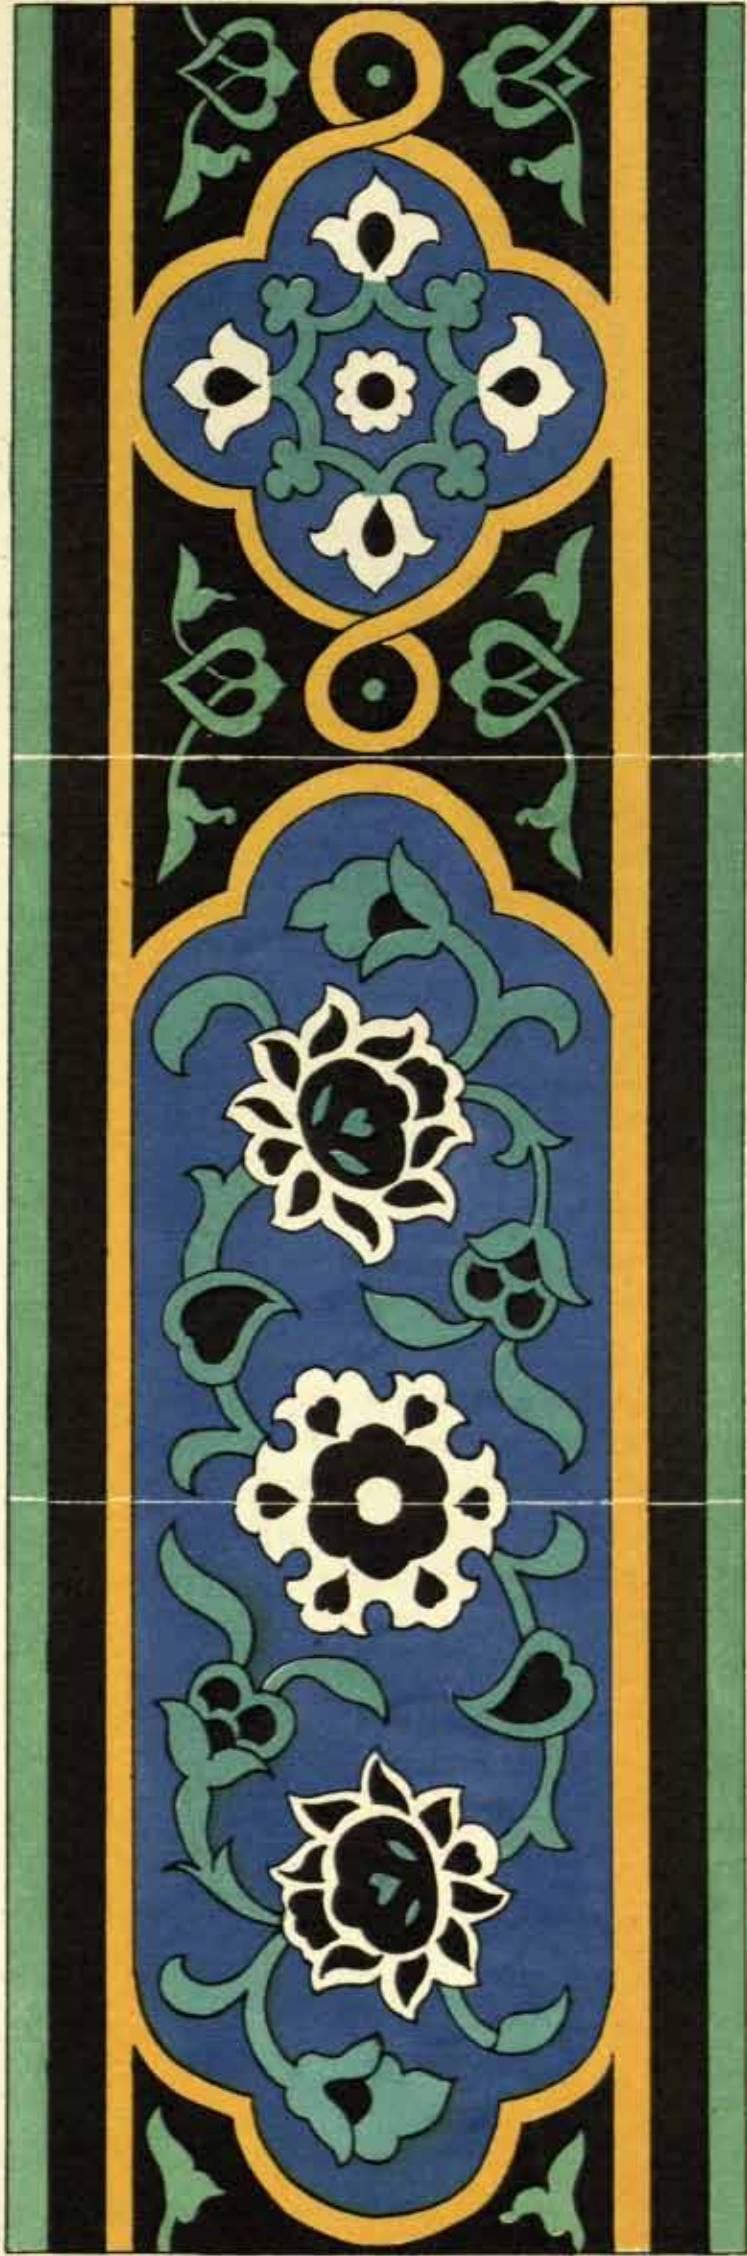
Fig. 22. Later phase of Second Period

Scale 1:2.73

Among the tiles allotted in the chronological diagrams to the second period there remain two more distinct groups to be described. It is in these two groups that the first dates are found. The tiles composing the first of these two groups show a further development and elaboration of the floral motives already illustrated; an increased freedom of line; the use of all the colours (black, white, dark blue, turquoise, green, and yellow) found in the earliest tiles, but with this important difference, that whereas in the earliest tiles all six colours are found on a single tile, producing the richest effect imaginable, in the tiles of the group now being discussed there are never more than four colours on any one tile, and more frequently only three, and sometimes only two. The whole colour-effect is consequently much less rich. White, yellow, turquoise, green, and dark blue are all used as grounds. The colours are still very evenly laid on and carefully stippled. Fig. 22, illustrating the

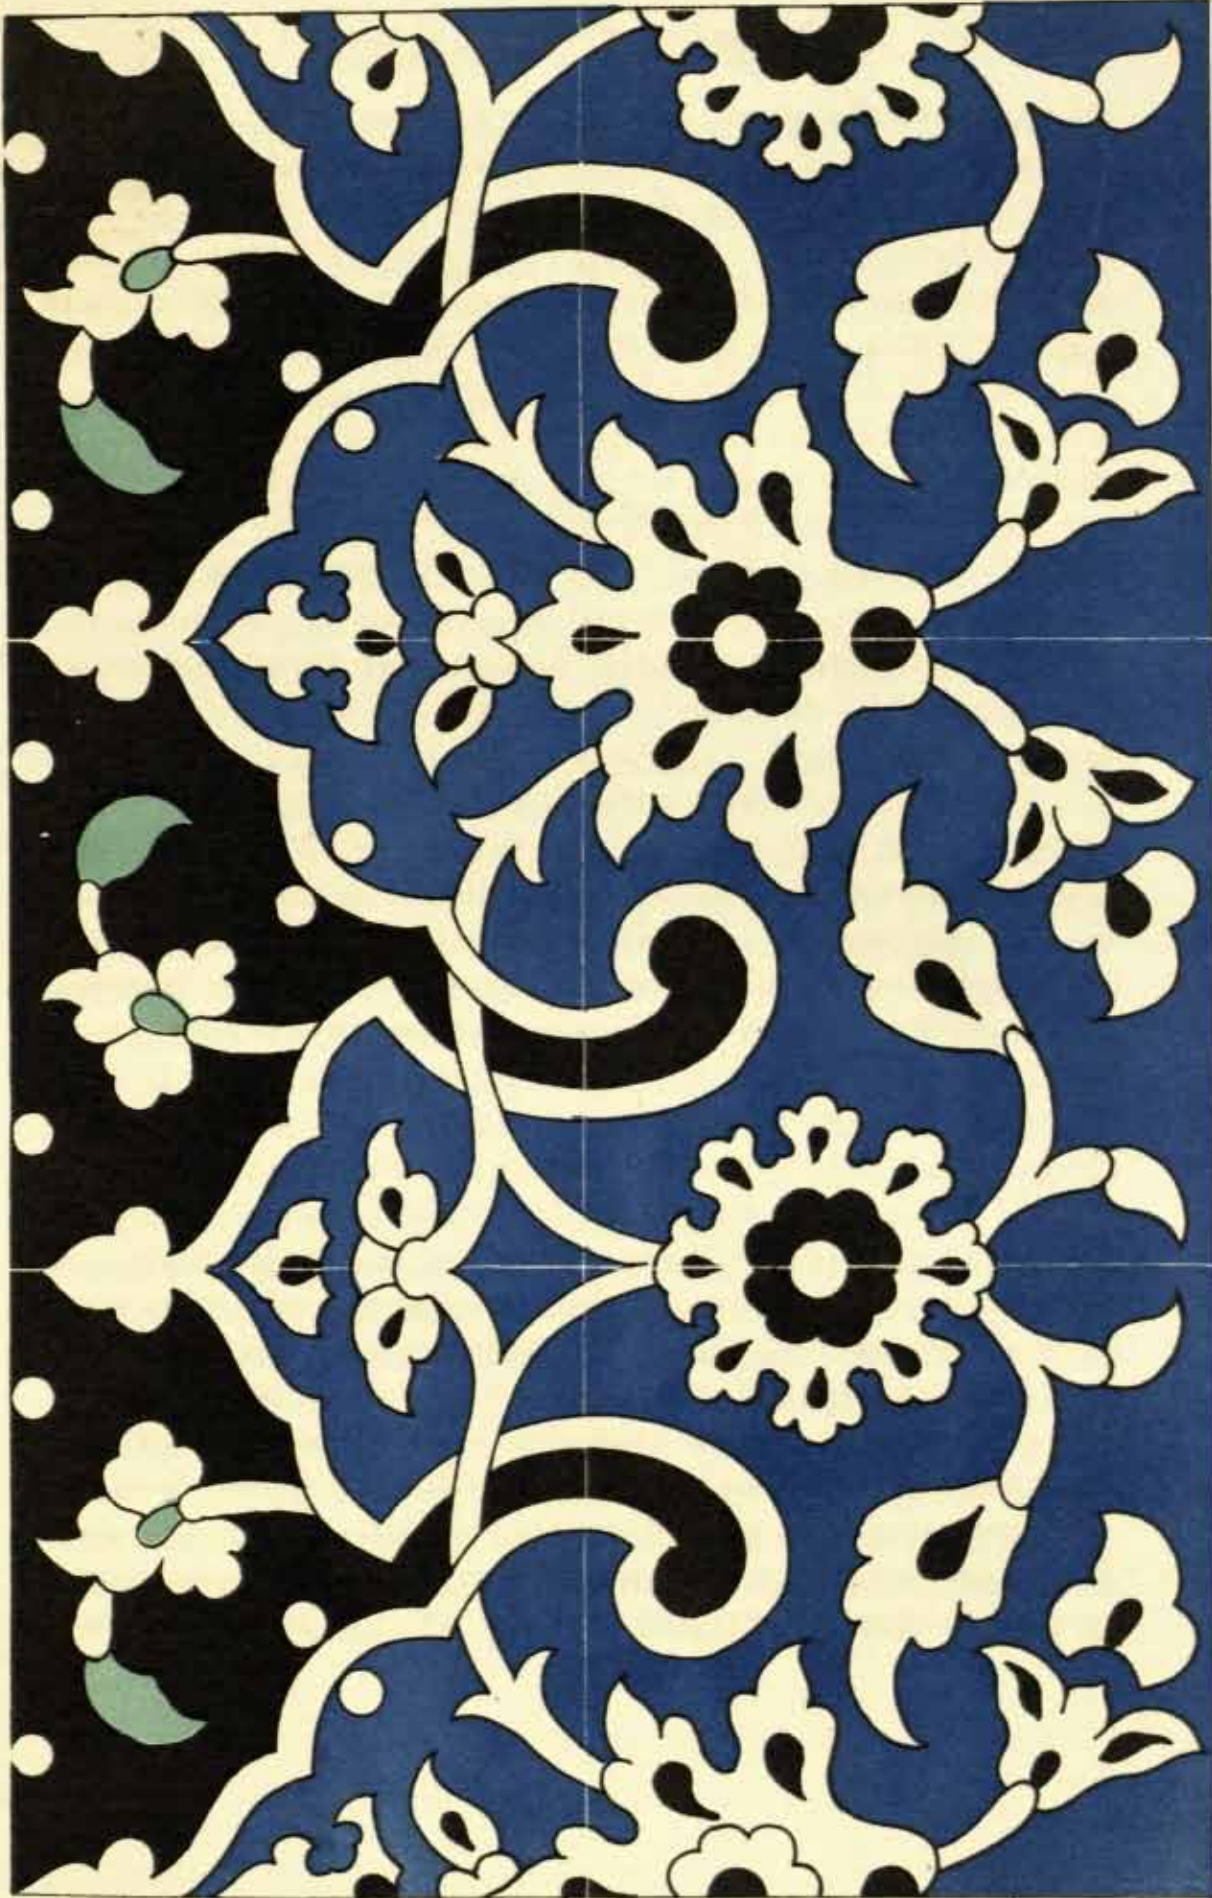
Fig. 23. A design in imitation of battlements ('Sharafat')

Scale 1 : 3

intention to the stone battlements (known as 'Sharafât') that crown the walls of so many Muslim buildings. The reconstruction of this design is shown in Fig. 23. No doubt these tiles were made to crown the top of the octagon. At one time there must have been more than 1,200 of them; now only eight badly mutilated specimens remain. The battlements are outlined in white, their ground is dark blue and the ground of the spaces between them is black; the flowers and stems are white where they are laid on a blue ground, but some turquoise is used for those on a black ground. The other design consists of two interlacing stems, each having large flowers; the stems are white; the flowers are mostly black-and-white, but turquoise is used in some of them; the ground is dark blue. The design is bold and is evidently made to tell at a distance. The flowers are similar to the flowers of the border patterns illustrated in Fig. 16, but are further elaborated. This design is shown between the 'Sharafât' and the inscription in Fig. 41, which represents an attempt to reconstruct the original design of the tile decoration on the parapet wall. The evidence upon which this reconstruction is based will be discussed later. The inscription drawn in this reconstruction no longer exists on the walls of the shrine except for a few fragments found on the drum and there used to divide the panels, formed of early nineteenth-century tiles, that run below the windows on the western side of the drum. About three-eighths of the splendid tiles that formed this inscription have, however, been discovered in various store-rooms existing in the Haram al Sharîf. These tiles have been sorted and arranged in their proper order in the Mugharba Mosque, which is being used as a museum for tiles and other objects found in the Haram. The tiles forming the inscription belong to the same group as those illustrated in Figs. 23, 24, and 41. They

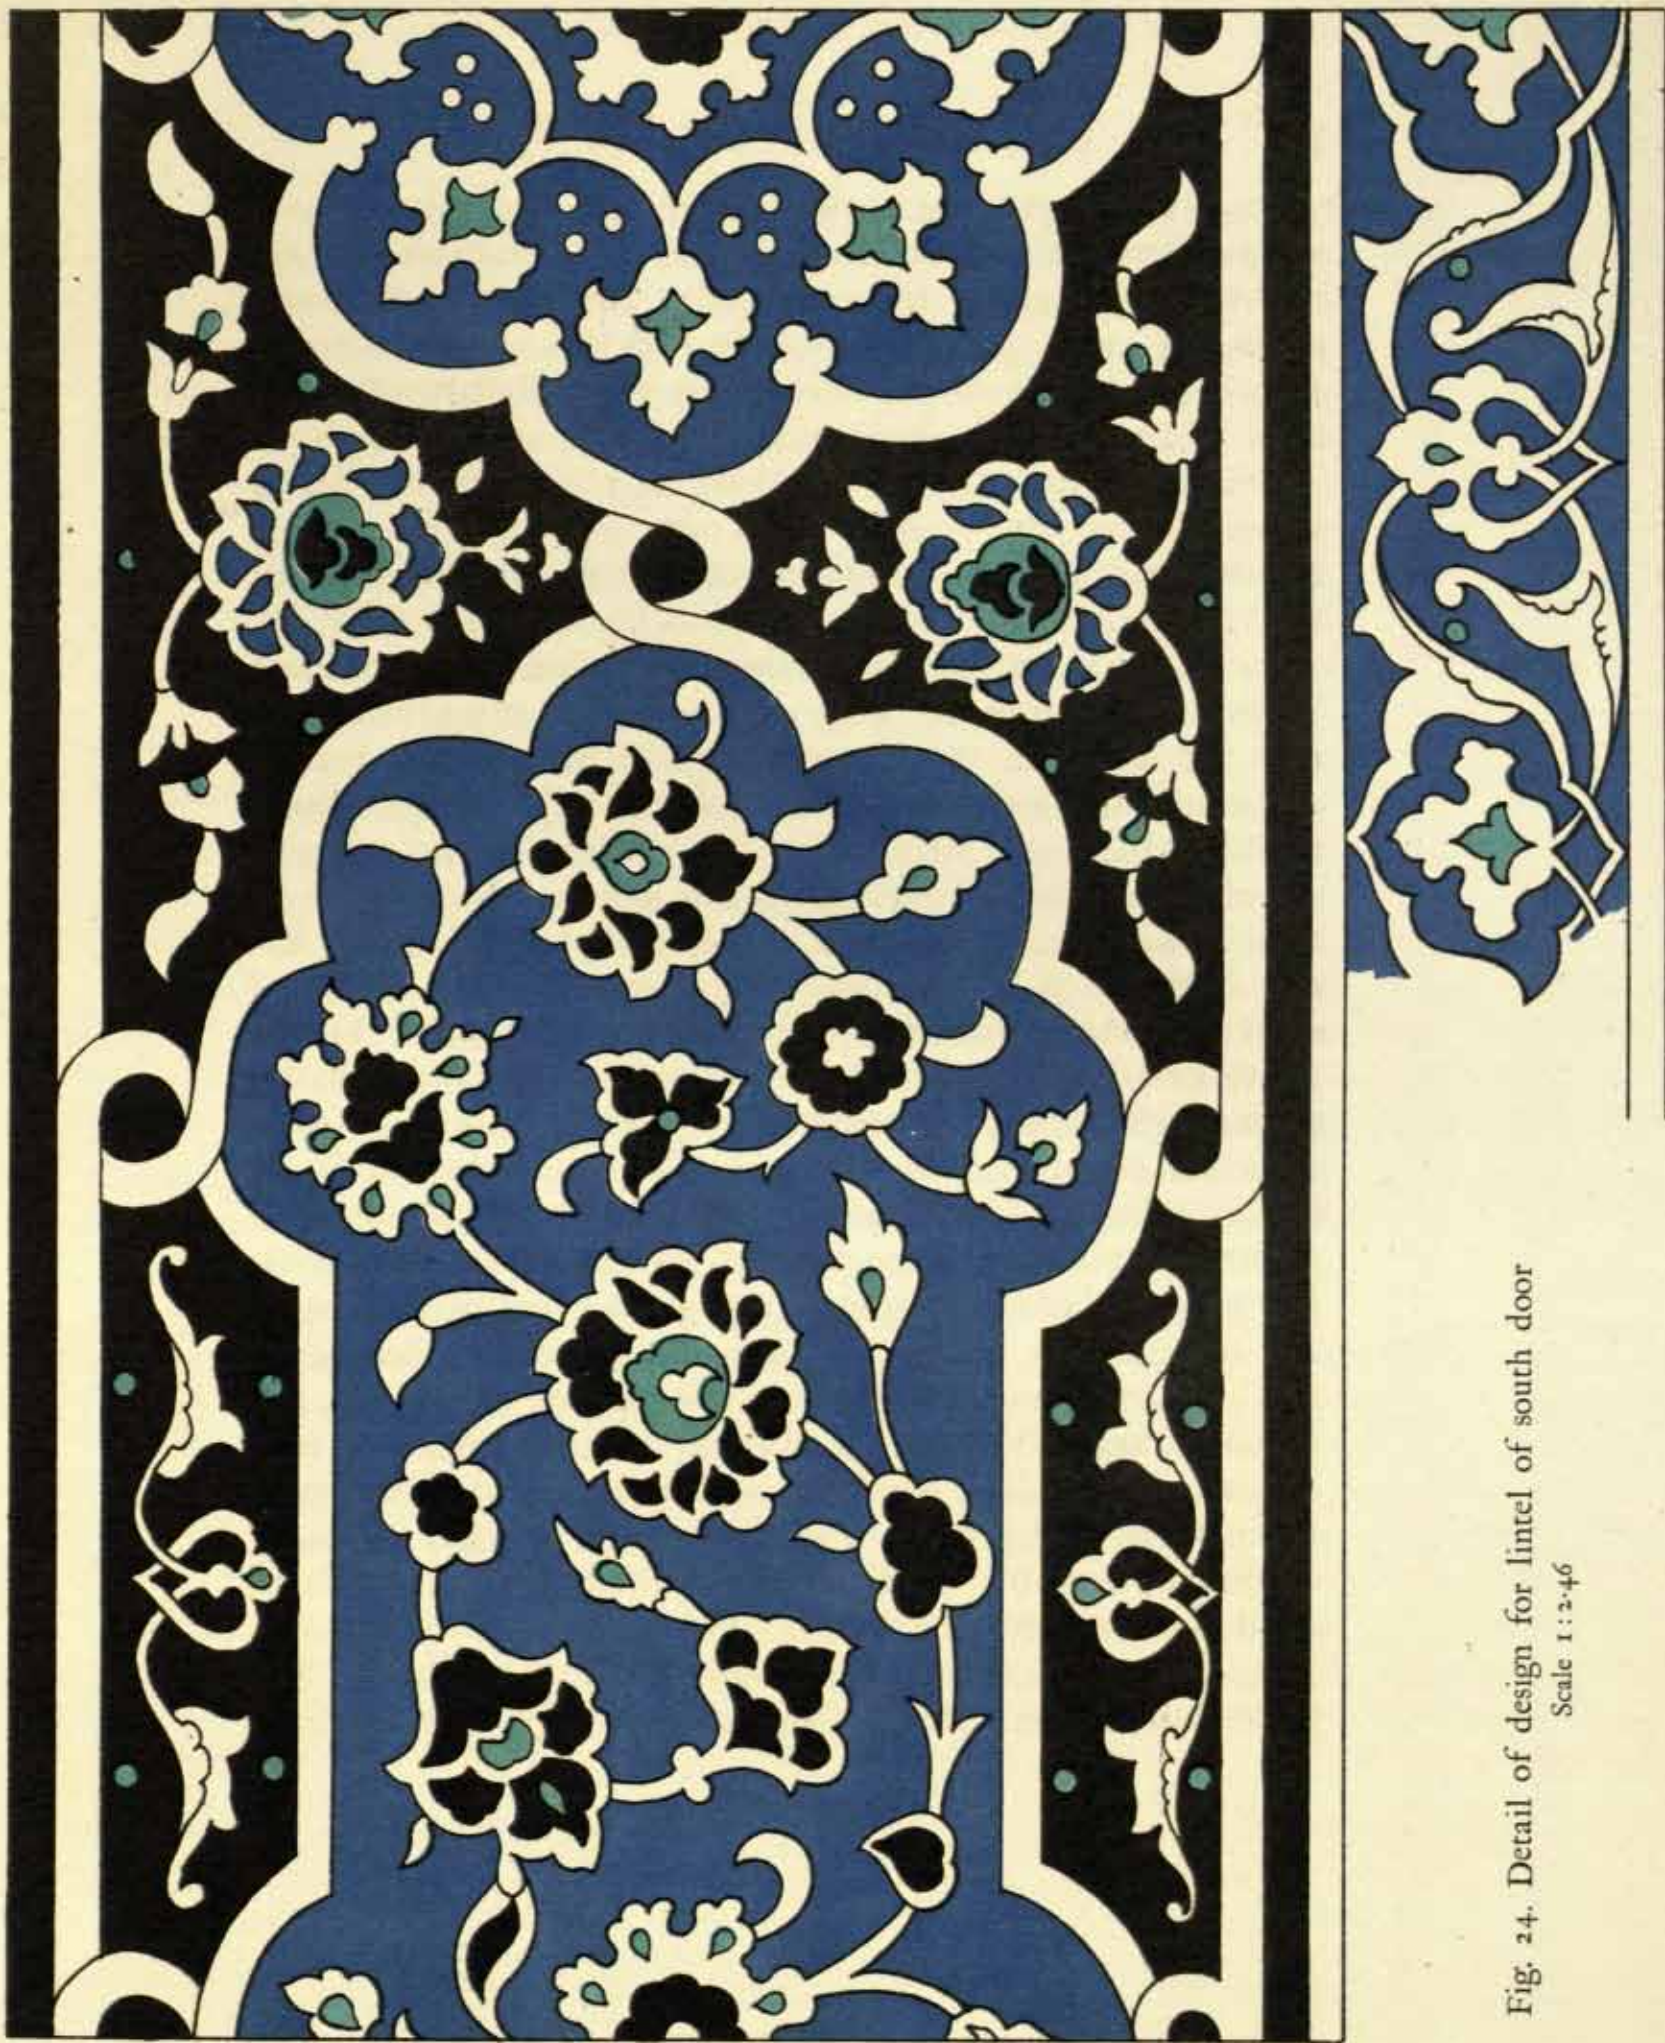
Fig. 24. Detail of design for lintel of south door
Scale 1 : 2.46

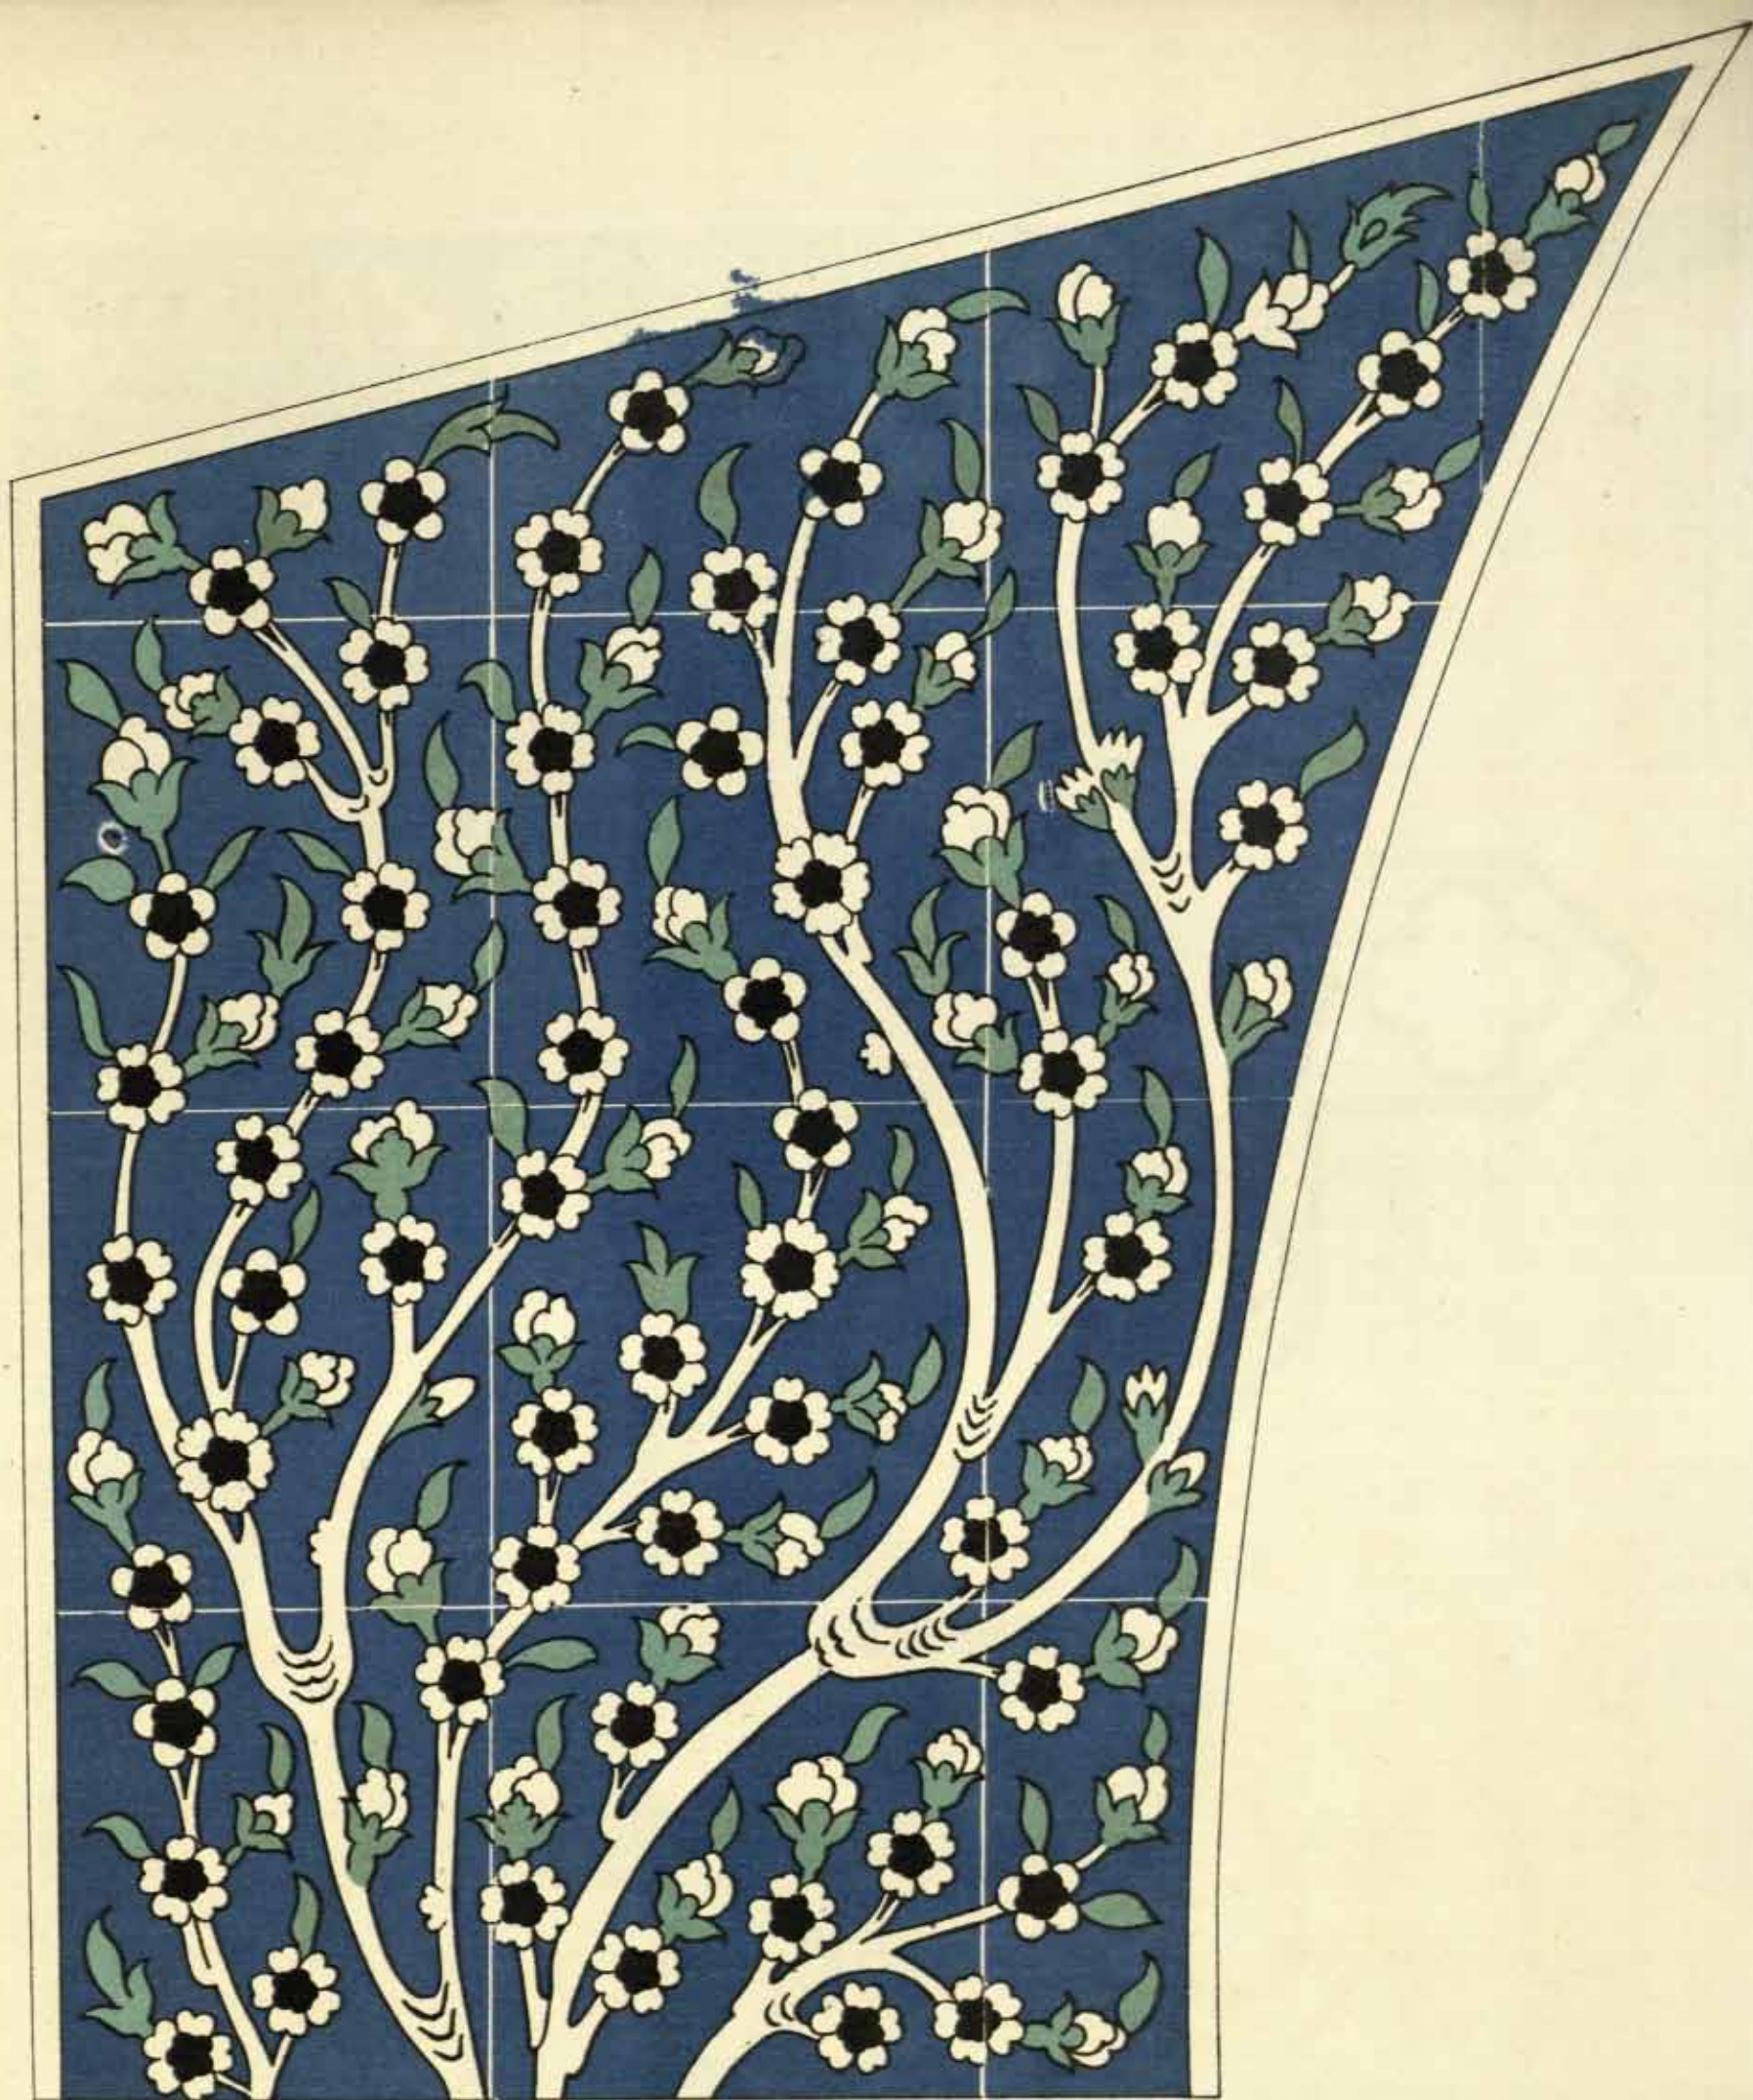
Fig. 28. South Portico arch : decoration of abutments

Scale 1 : 3. The bottom row of tiles is missing

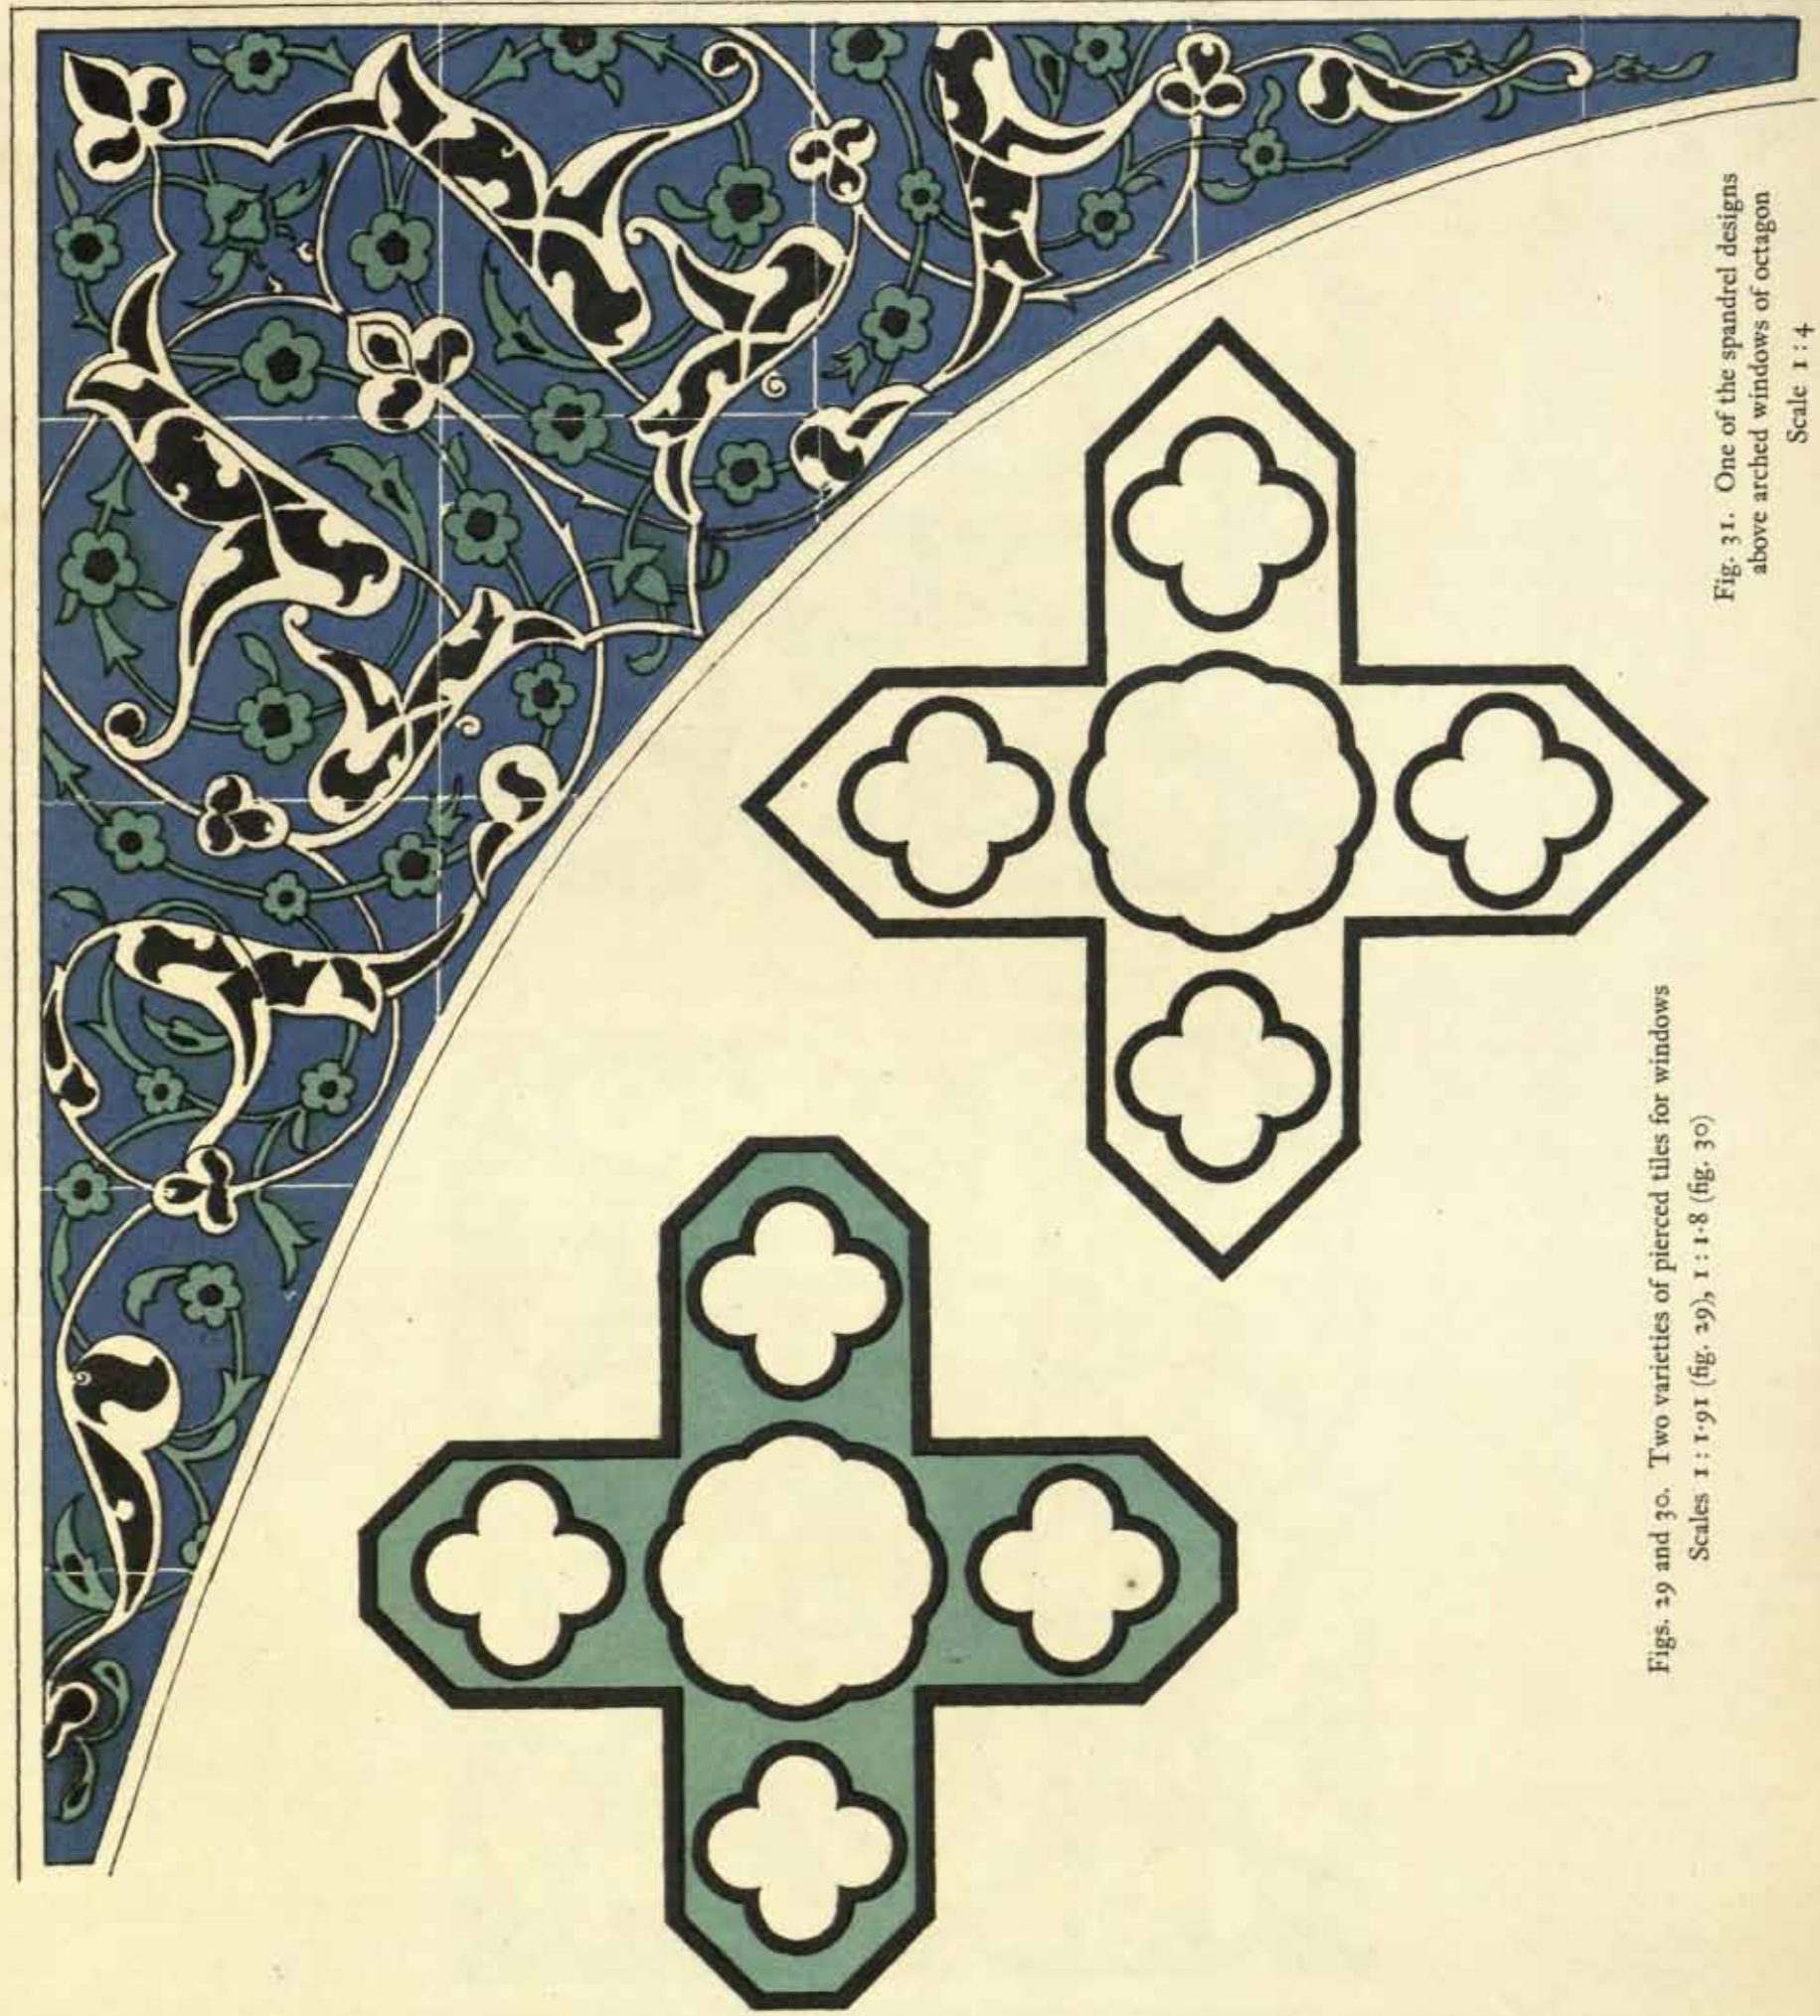
Figs. 29 and 30. Two varieties of pierced tiles for windows
Scales 1:1.91 (fig. 29), 1:1.8 (fig. 30)

the architrave are filled with sixteenth-century tiles, as are the spandrels and the portico, the blind bay being filled with fifteenth-century tiles. This drawing is only intended to illustrate in broad lines some of the conclusions reached from the examination that has been made. It would not be hard to justify a more elaborate reconstruction. Inscribed panels might be placed in the architrave above the windows and also in the blind bay and instead of only turquoise-blue quoins to the windows enclosing pierced tiles of black on white, aubergine quoins might be used for some windows, as well as other varieties of pierced tiles (see Figs. 29 and 30).

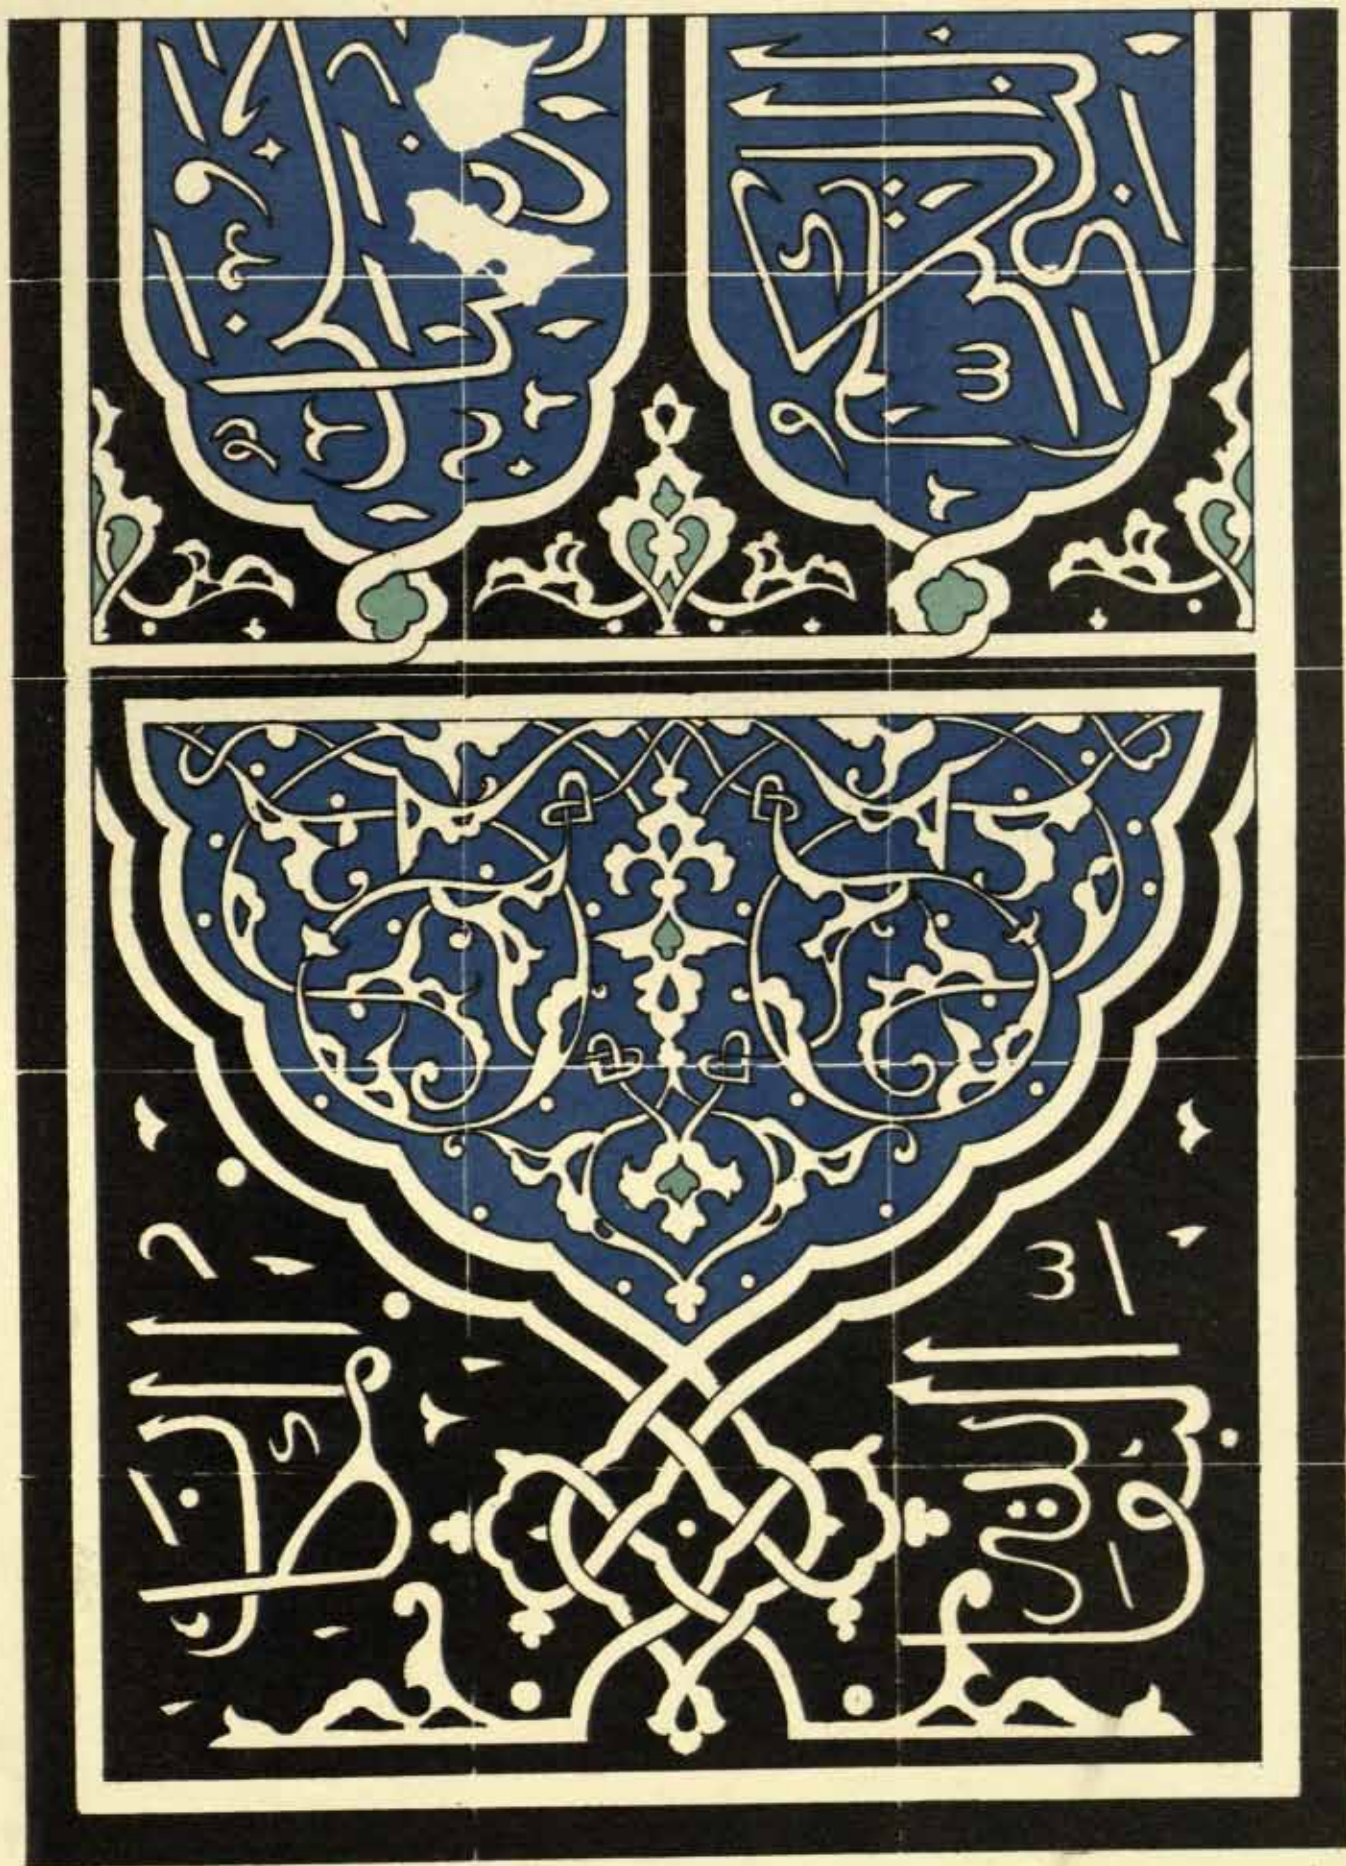
Fig. 34. Terminal decoration of a panel containing 73rd verse, chapter xxix of the Koran

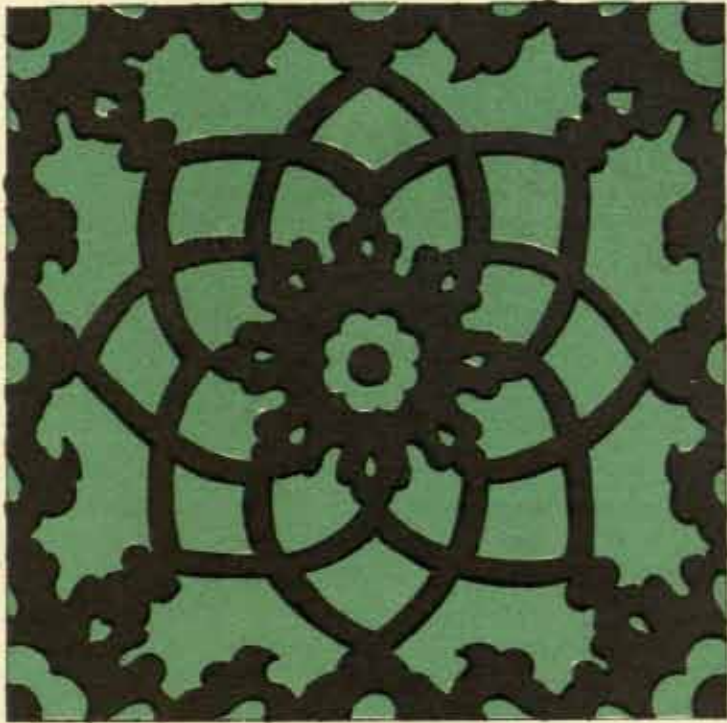
Fig. 35. Specimen of a design found in many varieties of colour
Scale 1 : 2

The last category of the tiles grouped in the second period consist of tiles that resemble those of the type just described, but show a falling off both in draughtsmanship and in technique. Forms are expressed with less precision and with less understanding of the original intention, and the application of the colour is no longer so carefully attended to. The fine stippled effect is not found. The colour is laid on roughly, so that the strokes of the brush are visible and the result uneven. Though the floral pattern (Fig. 40) that runs under the cornice on the north façade, and of which specimens are found in the blind bays of the north-east façade, belongs, in its design, rather to the preceding group, its execution shows that the tiles were made at the same period as those of the group now being considered. Many of the cornice tiles also belong to this period, so do a proportion of the tiles forming the window borders and the inscriptions above the east and the south doors on the main walls of the octagon. Another inscription, similar in workmanship, exists above the Mihrâb in the Dome of the Chain. This inscription is dated A.H. 969 (A.D. 1561). To the same period may be attributed a number of tiles of the design shown in Fig. 35. This design is found in many varieties, in green, yellow,
